Maryland Historical Trust

Maryland Inventory of Historic Properties number: HO-660

Name: Pfefferkorn Rd. over Middle Patuxent Riv.

Name and SHA No. Pfefferkorn Road over Middle Patuxent River/HO31

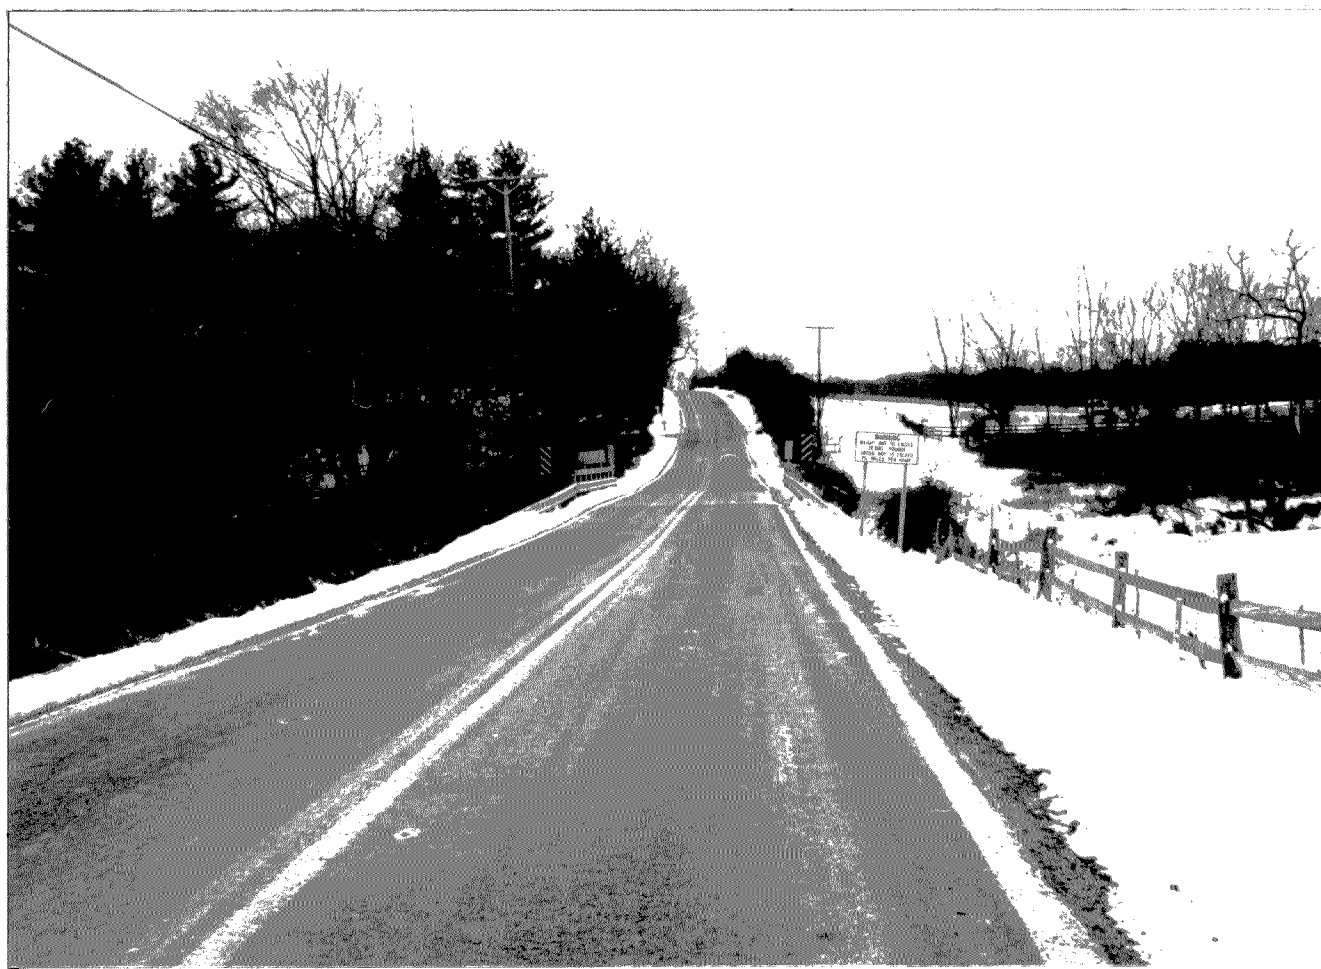
Number 1 of 4
2 of 23

Description NORTH APPROACH LOOKING
SOUTH

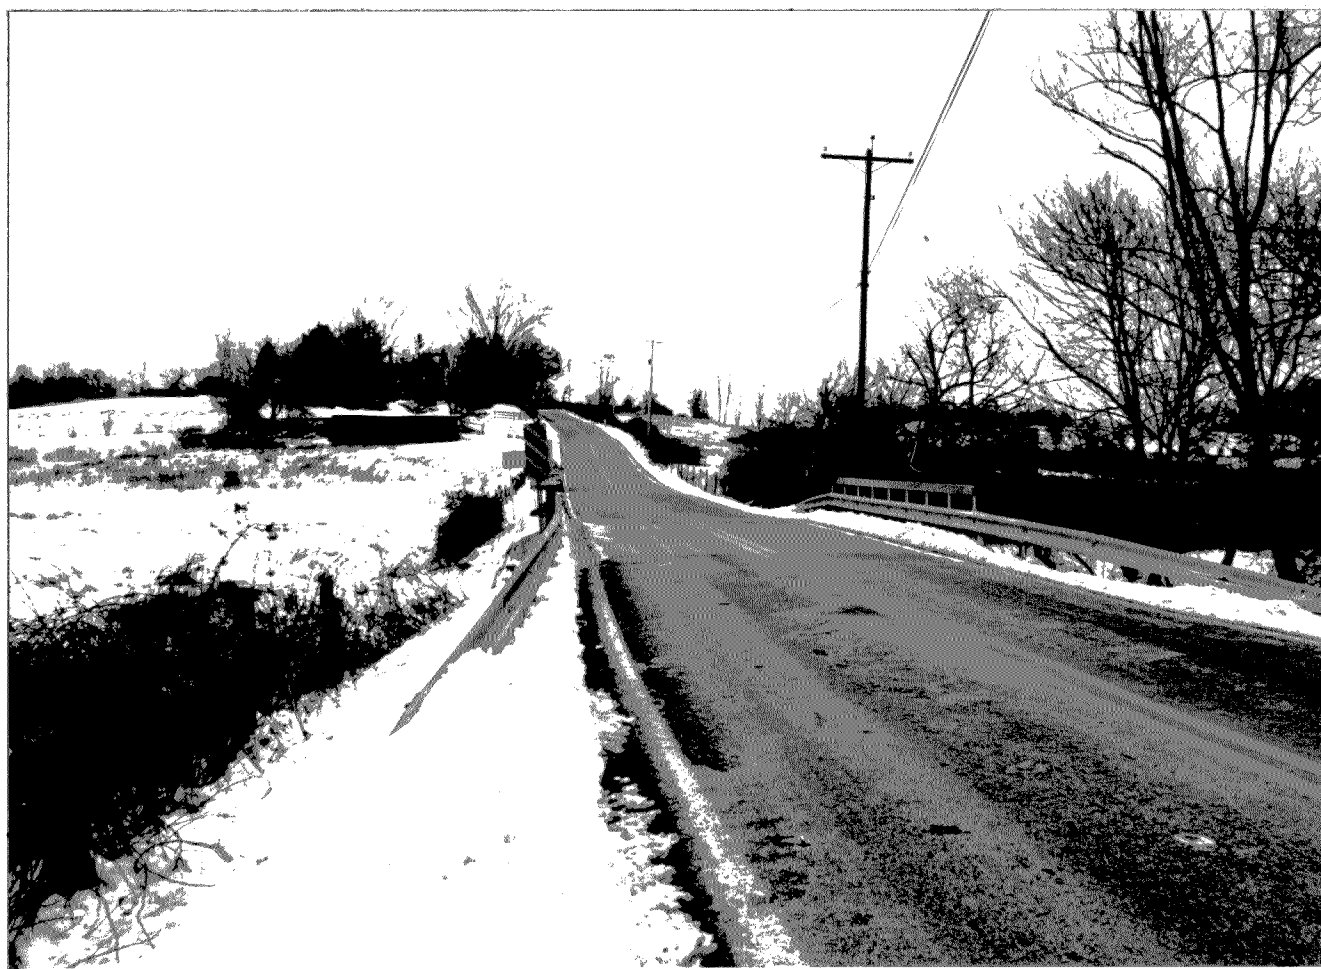
Number ² ~~4~~ of ⁴ ~~33~~

Description SOUTH APPROACH LOOKING NORTH

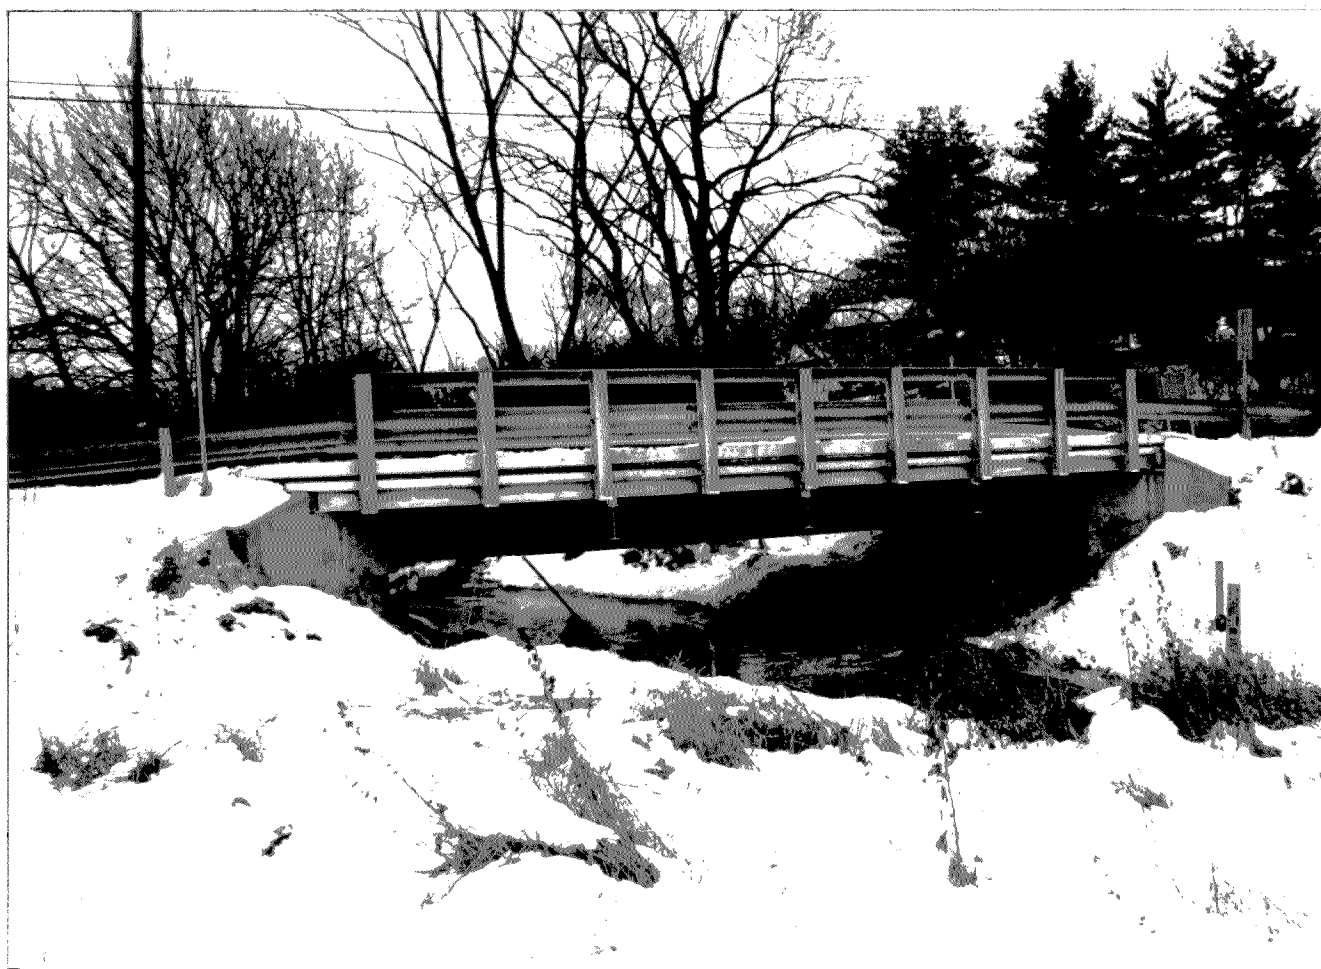
Number 3 of 4
9 of 33

Description WEST ELEVATION LOOKING

SOUTHEAST

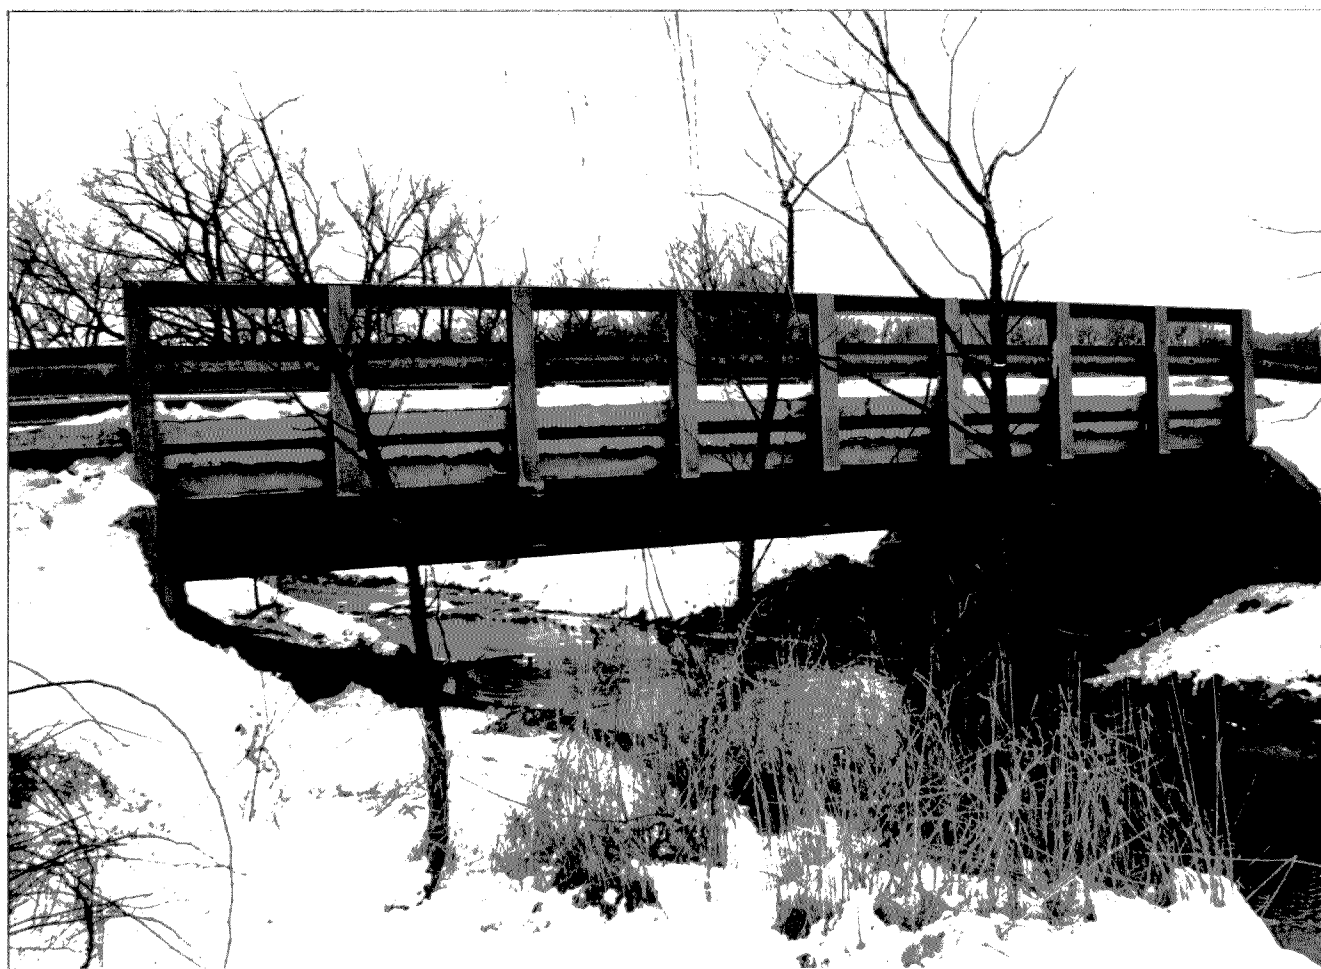
Number ⁴ ⁴ 16 of 33

Description EAST ELEVATION LOOKING NORTH
